Laxdale River report - 22.02.2012, Removal of banking, unrestricted access to river by cattle and possible damage to active redds.

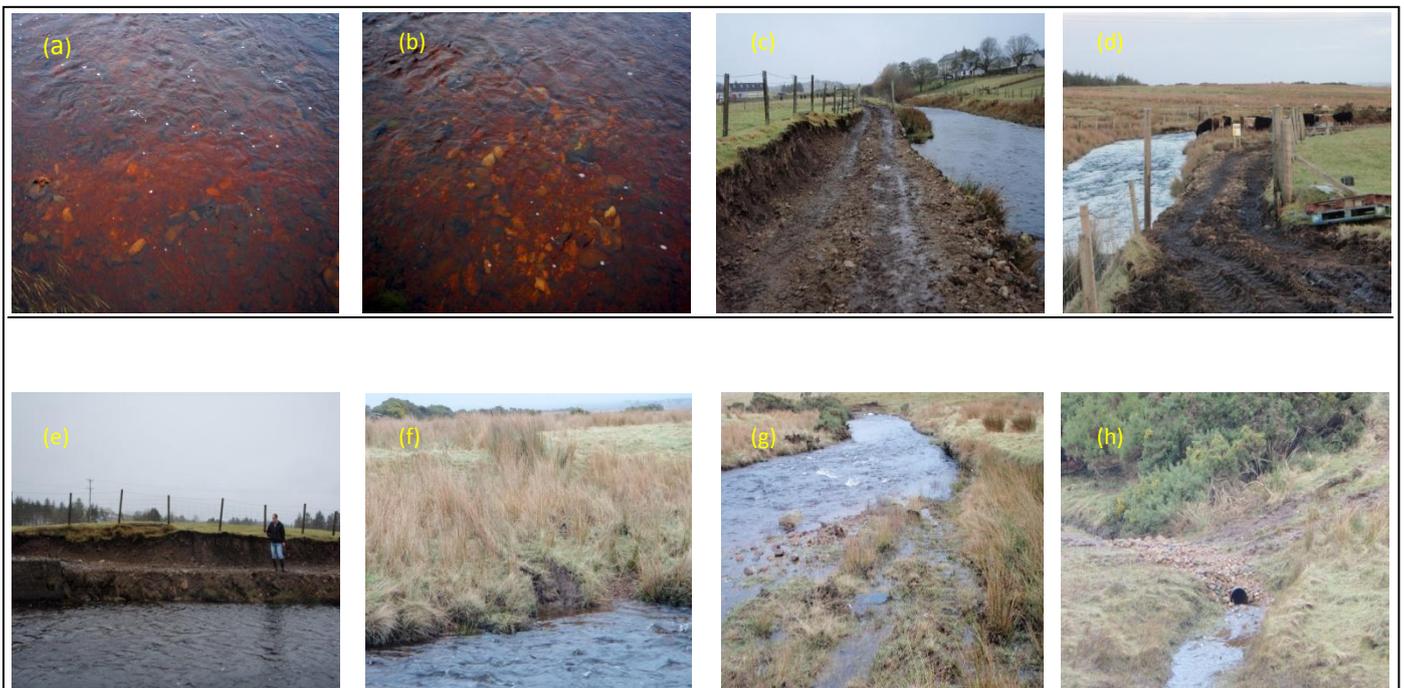
During the walk over assessment it was noted that the river course had been crossed at several points by a caterpillar type vehicle with indications that some of these crossings were recent. Removal of banking was confirmed and it was also apparent that unimpeded cattle access to the river was also likely to cause further degradation along some sections. Gravel beds in river adjacent to area of bank removal appeared to have scoop marks that may be an indication that material had been excavated from the water course. It was felt by OHFT that signs of gravel removal were too large and too regular as to be caused by spawning Salmonid activity. Further removal of river substrate was positively identified down stream of the section in question and had been used to culvert a smaller tributary stream.

Concerns are raised that important redds containing ova may have been disrupted and that increased sediment laden run off may now be entering the river during periods of heavy precipitation. See figures 1 and 2 for map of area and photographic evidence. Distribution of this report was made to the clerk of W.I.D.S.F.B.

Figure 1. (a) and (b) recently disturbed redds, (c) removed bank, (d) removed section of fence and cattle on banking, (e) removed bank from opposite bank showing substrate entering river, (f) and (g) caterpillar tracks entering and leaving river course, (h) river pebbles used to culvert tributary stream.

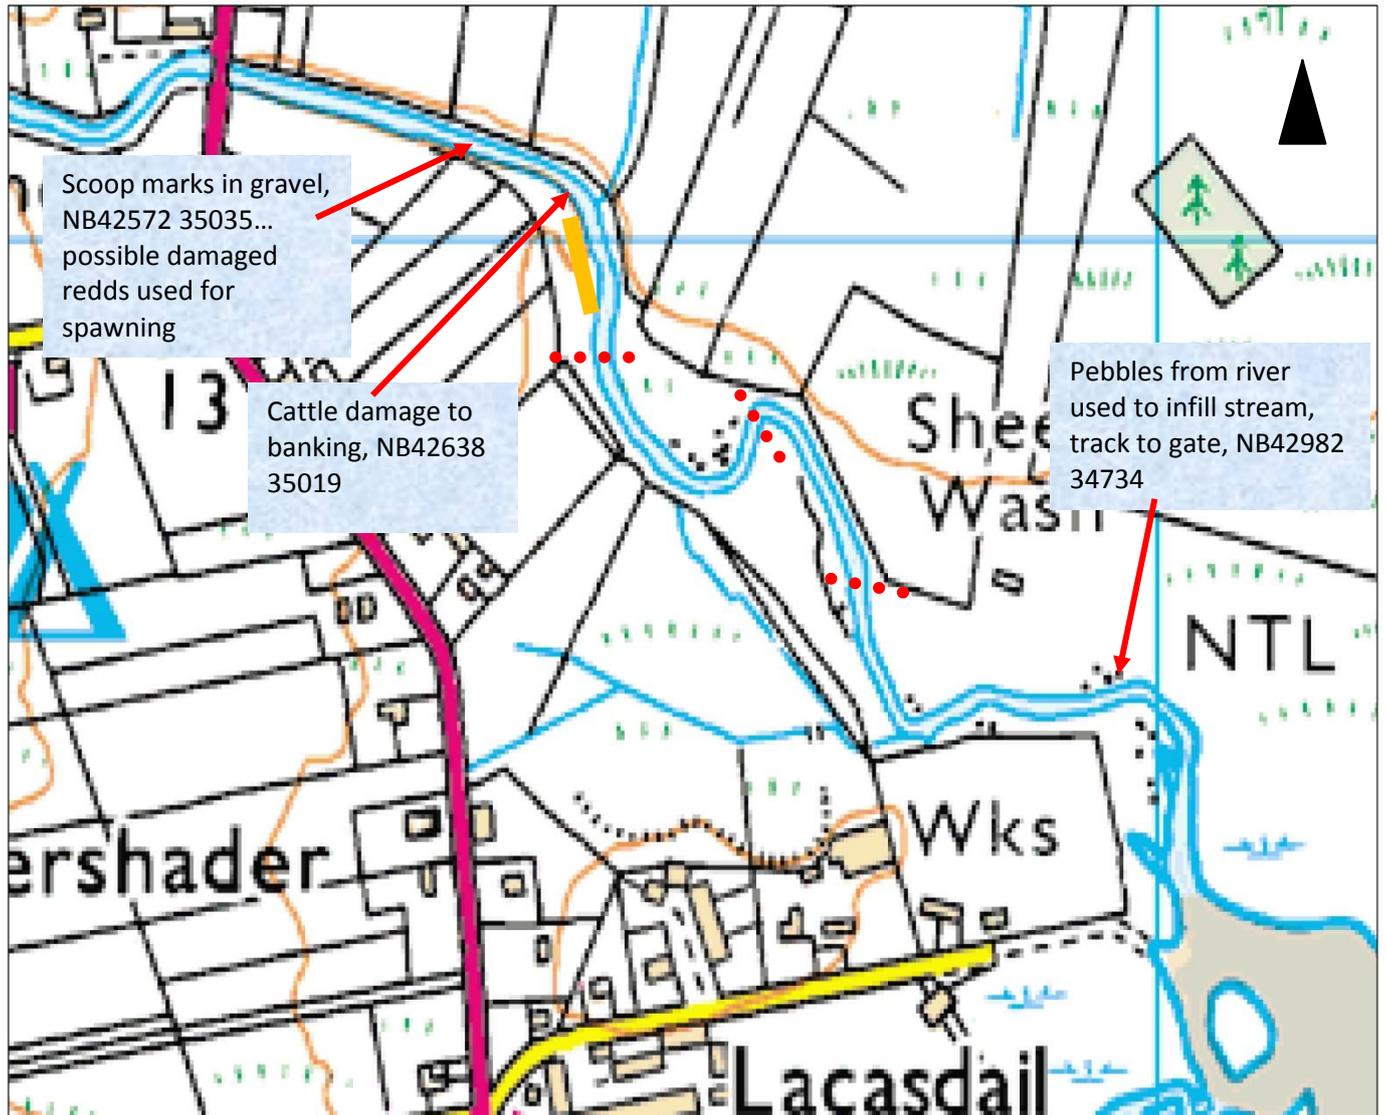
Figure 2. Map of area showing location of apparent excavated river substrate, bank erosion from cattle, river crossings and infill of stream consisting of river bed material.

Uprooted gorse and loose material

Tracks crossing river course NB42654 34960, 42766 34884 & 42818 34766
